PENNSYLVANIA HISTORIC RESOURCE SURVEY FORM PHOTO/SITE PLAN SHEET

PENNSYLVANIA HISTORIC RESOURCE SURVEY FORM - DATA SHEET

Surveyor Name/Title: Robert Wise Date: 6/16/2000
Project Name: Whitpain Township Historic Resource Survey
Organization: Robert Wise Consulting/Whitpain Township Telephone: (610) 722-5818
Street and No.: Station Square 1, Suite 104, 37 North Valley Road
City, State: Paoli, Pa Zip Code: 19301
Additional Survey Documentation: _____ n/a
Associated Survey Codes: _____ n/a

Survey Code: 063 Tax Parcel/Other No.: 66-00-04246-00-8 Block 009A Unit 024
County: Montgomery 091 Municipality: Whitpain Township
Address: 1948 Morris Road
Historic/Other Name:

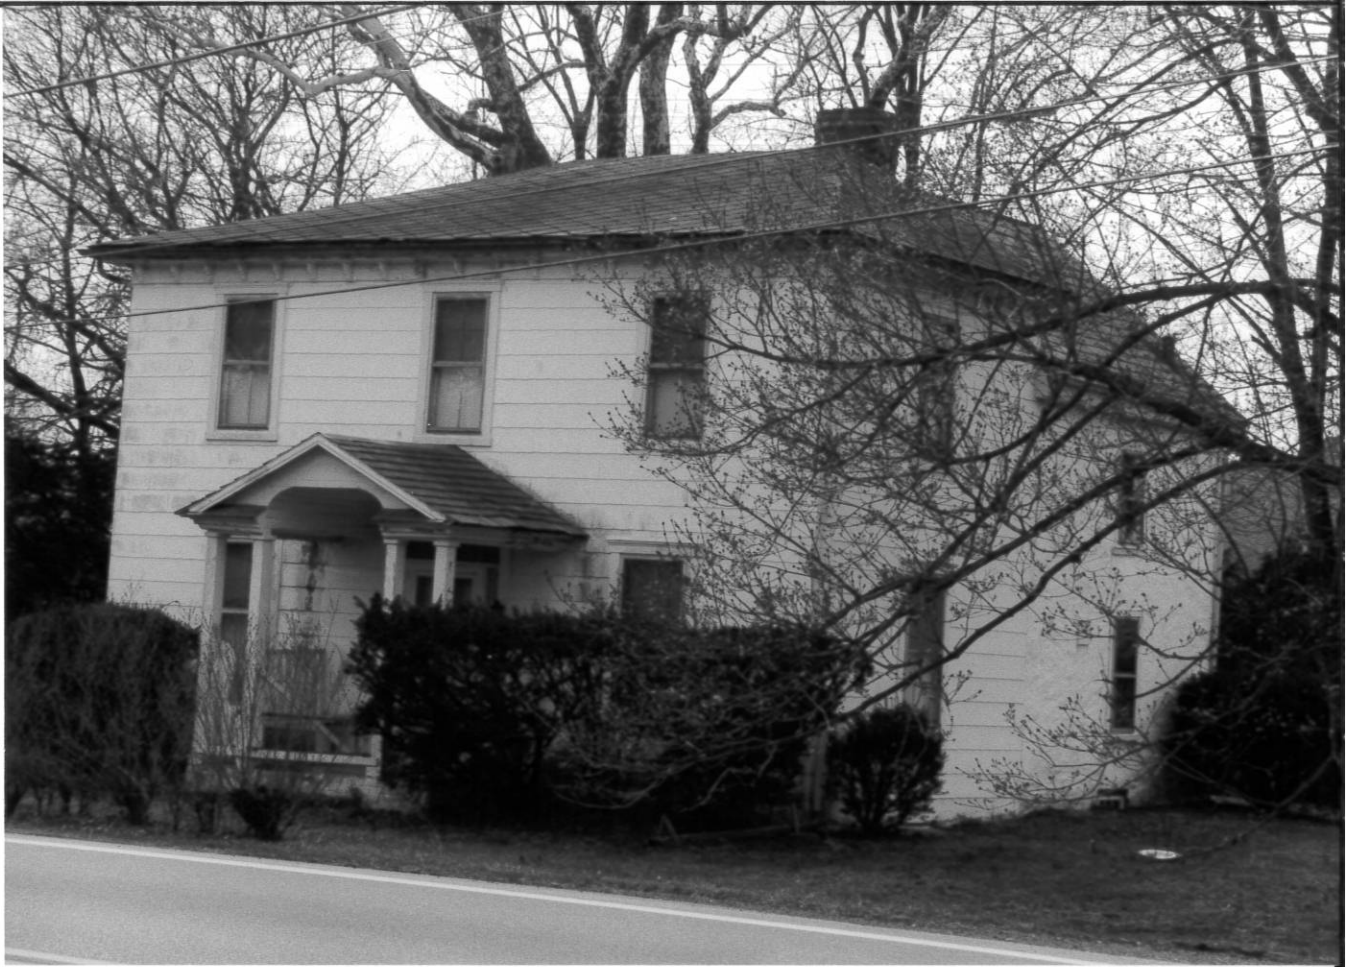
Standing across from 1925 Morris Road is this vernacular farmhouse. The original section, a two story, stucco over stone, gabled roof, vernacular structure is now the rear addition. The main section, fronting Morris Road, is a two story, hipped roof building, probably constructed at the turn of the 19th century. The core has a slate roof whose gable end is fronts Morris Road and the front addition. The main addition is a two story, three bay house with a hipped roof core (front) and a gabled roof rear addition. The siding is machine shingles, the roof is composed of diamond-shaped shingles. Under the eaves are scrolled brackets, and the window lintels have a decorative crown molding. An entry porch is composed of two twin square columns supporting a nicely carved entablature that is broken between the pairs of columns. Combined, the building is approximately 30' x 30'.

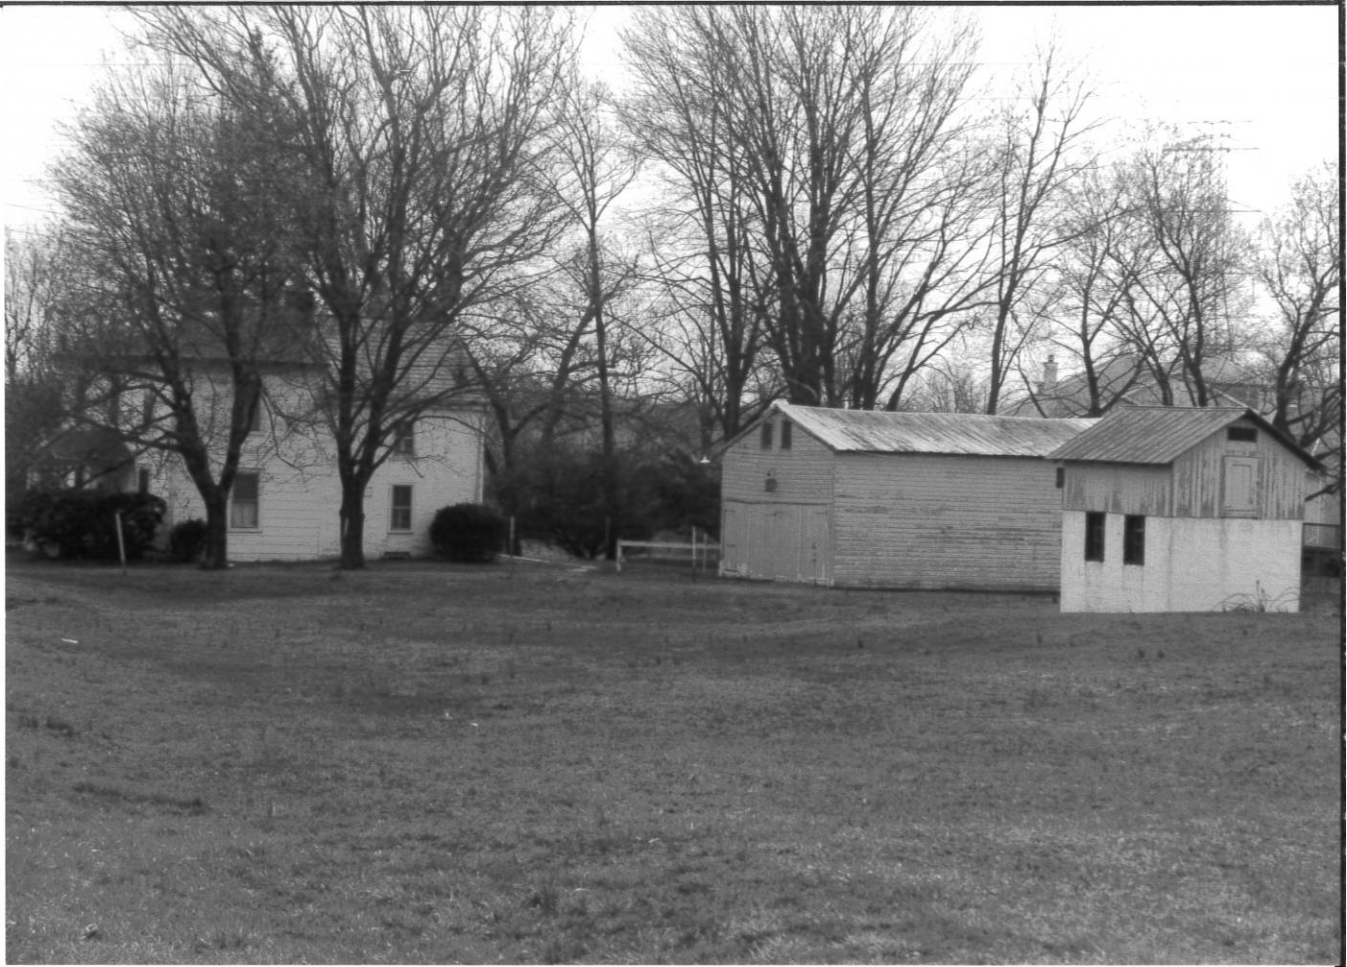
- (1) **Two Story Outbuilding.** Associated with this house are two out buildings. The first is a two story building with a stucco-covered foundation and a frame upper story. This gabled building has two windows on the side and one in the second story gable.
- (2) **Carriage House.** The second building is a two story carriage house. This building is a gable end frame building sitting on an axis perpendicular to that of the house.
