PENNSYLVANIA HISTORIC RESOURCE SURVEY FORM PHOTO/SITE PLAN SHEET

Municipality: Whitpain Township

Address: 737 Hoover Road

Surveyor Name/Title: Robert Wise Date: 6/16/2000
Project Name: Whitpain Township Historic Resource Survey
Organization: Robert Wise Consulting/Whitpain Township Telephone: (610) 722-5818
Street and No.: Station Square 1, Suite 104, 37 North Valley Road
City, State: Paoli, Pa Zip Code: 19301
Additional Survey Documentation: n/a
Associated Survey Codes: n/a

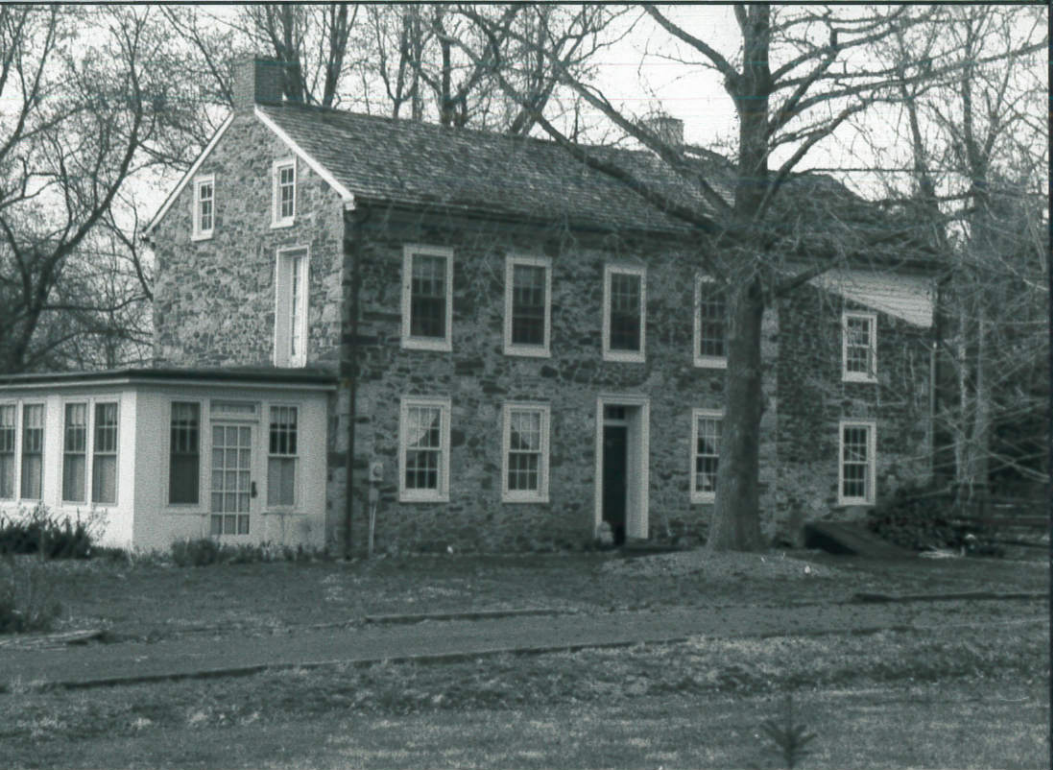
This house, c. 1790, is a Colonial style house consisting of three parts. The core is a four bay wide, two story, end gabled structure with an end-gabled wood shingled roof. The roof extends on the NE end to cover a two story main stone addition. A molded cornice runs along the eaves. Details include flush brick chimneys on each end of the core, a deeply inset paneled door with three light transom, and 6 over 6-light sash windows. The windows have a thick molded surround, a rear feature for this rather vernacular house. There are also two large (2 over 4 light) attic windows under the exposed gabled end. The masonry is rough fieldstone. The main addition is attached to the NE end of the core, and originally was a 1.5 story stone structure with a shed roof. Later framework was attached to the top of the walls to create the present two-story structure, in line with the core. The framework is covered in clapboard. There is one window on each floor, slightly smaller than those on the core. An early twentieth century porch addition is attached to the SW end. It is an enclosed structure with modillion course under the eaves. Its flat roof is accessed from a multi-paned door on the second floor of the SE end of the core. With additions, the house measures 40' by 18'.

Classification: The house is in excellent shape. Due to alterations, it is a Class I resource. (It also is located in a modern development and thus has lost its context as a farmhouse.)
