PENNSYLVANIA HISTORIC RESOURCE SURVEY FORM PHOTO/SITE PLAN SHEET

Address: 978 DeKalb Pike

Surveyor Name/Title: Robert Wise Date: 6/16/2000
Project Name: Whitpain Township Historic Resource Survey
Organization: Robert Wise Consulting/Whitpain Township Telephone: (610) 722-5818
Street and No.: Station Square 1, Suite 104, 37 North Valley Road
City, State: Paoli, Pa Zip Code: 19301
Additional Survey Documentation: n/a
Associated Survey Codes: n/a

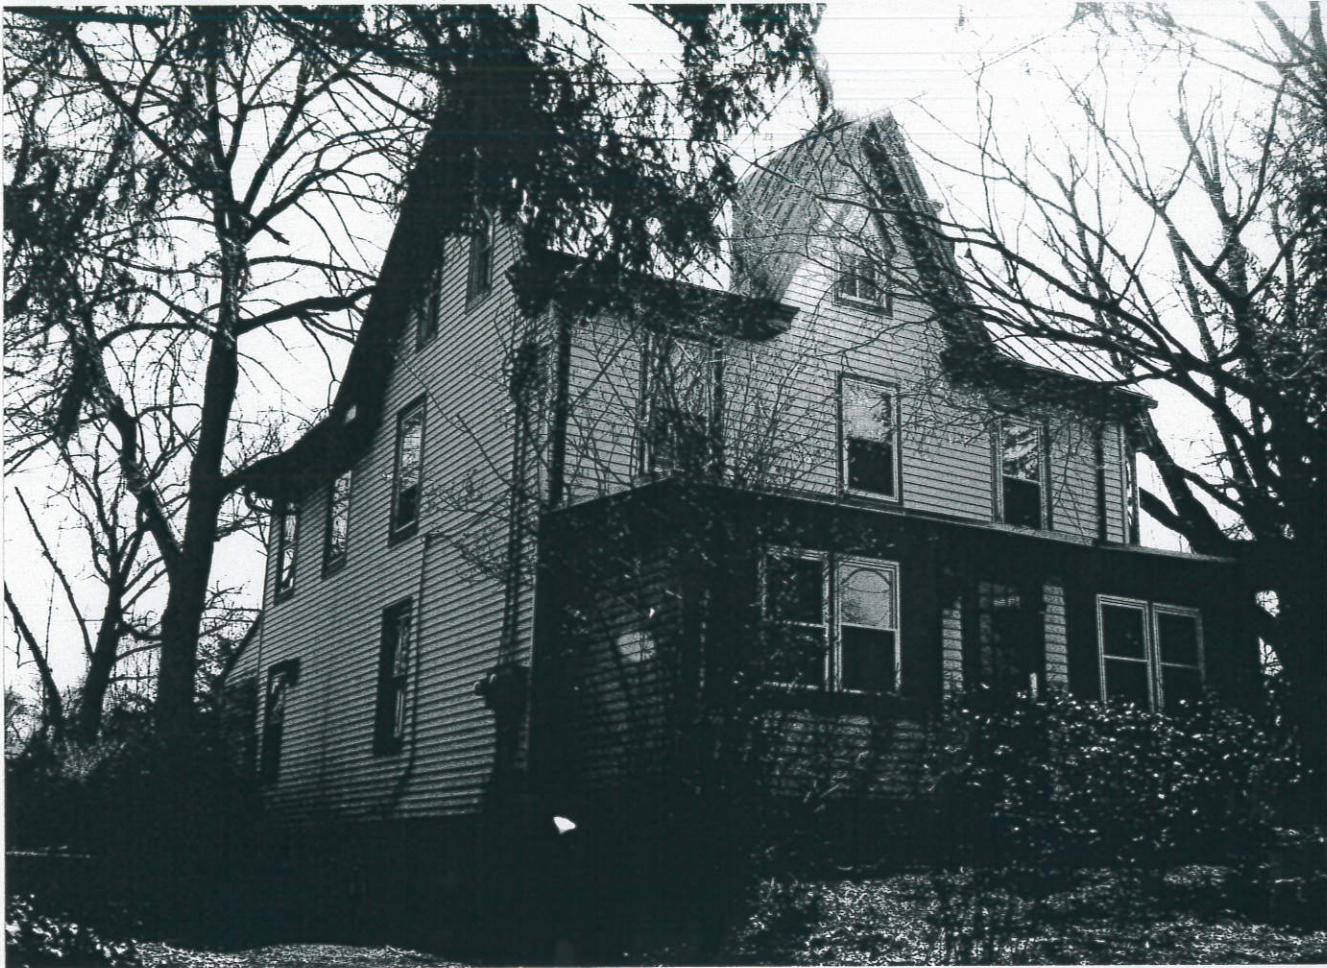
978 DeKalb
#1

This Gothic influenced Victorian style house is 2.5 stories, 3 bay wide, with a standing seam, steeply pitched, end gabled, cross axial roof. The building consists of the 3 bay core with two rear additions, forming a square. The key feature is the large gabled wall dormer centered on the front facade facing DeKalb Pike. Like 990 DeKalb, there is a pointed window under dormer and twin pointed windows at each end gable. Also notable is the 2-story bay window arrangement on the west end of the core, and the thick cornice trim of the roof. A terra cotta chimney adorns the west end of the house. Fenestration is 1x1 sash.

The building is highly altered for several reasons: modern vinyl siding; enclosed, full length, hip roofed, front porch; and the wooden exterior stairway attached to the second floor of the southwest addition.
