PENNSYLVANIA HISTORIC RESOURCE SURVEY FORM PHOTO/SITE PLAN SHEET

Municipality: Whitpain Township

Address: 1155 DeKalb Pike

Surveyor Name/Title: Robert Wise Date: 6/16/2000
Project Name: Whitpain Township Historic Resource Survey
Organization: Robert Wise Consulting/Whitpain Township Telephone: (610) 722-5818
Street and No.: Station Square 1, Suite 104, 37 North Valley Road
City, State: Paoli, Pa Zip Code: 19301
Additional Survey Documentation: n/a
Associated Survey Codes: n/a

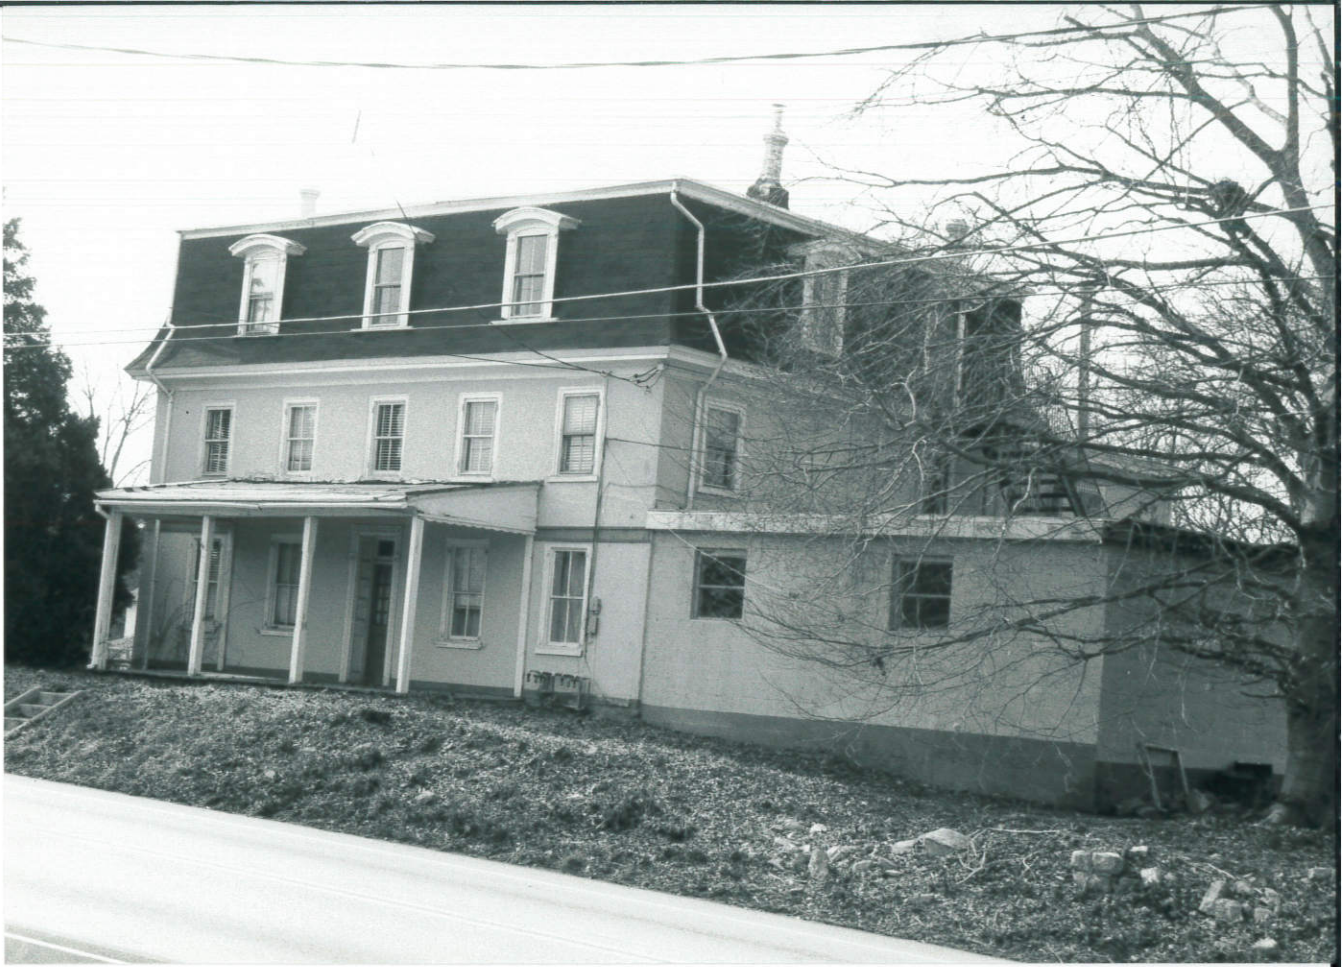
| Number | Description of View | Direction of Camera |
|---|---|---|
| 1 | House – façade (left) | |

This Mansard roofed, Second Empire house (1875) is similar to many others within the Township. The core is el-shaped, approximately 32 feet wide and 30 feet deep. It has three stories including an asphalt-shingled, Mansard roof. There are three additions: a 2-story, flat roof addition is attached to the rear of the house (in the el); there is a small, one-story extension on the south end; and a 1-story, flat roofed, cinder block addition extending from the north side of the house. The walls of the core are stucco over masonry. Fenestration consists of five bays of 2x2 sash windows. The main entrance is centered and consists of a paneled and glass-paned door flanked by paneled inset boards, molding, and transom. The entrance opens to a small, shed-roofed front porch. There are three, curved, pedimented dormers on the third floor of the main façade two on each end. A cornice caps the upper roofline. There are two, terracotta, octagonal chimneys on the core.

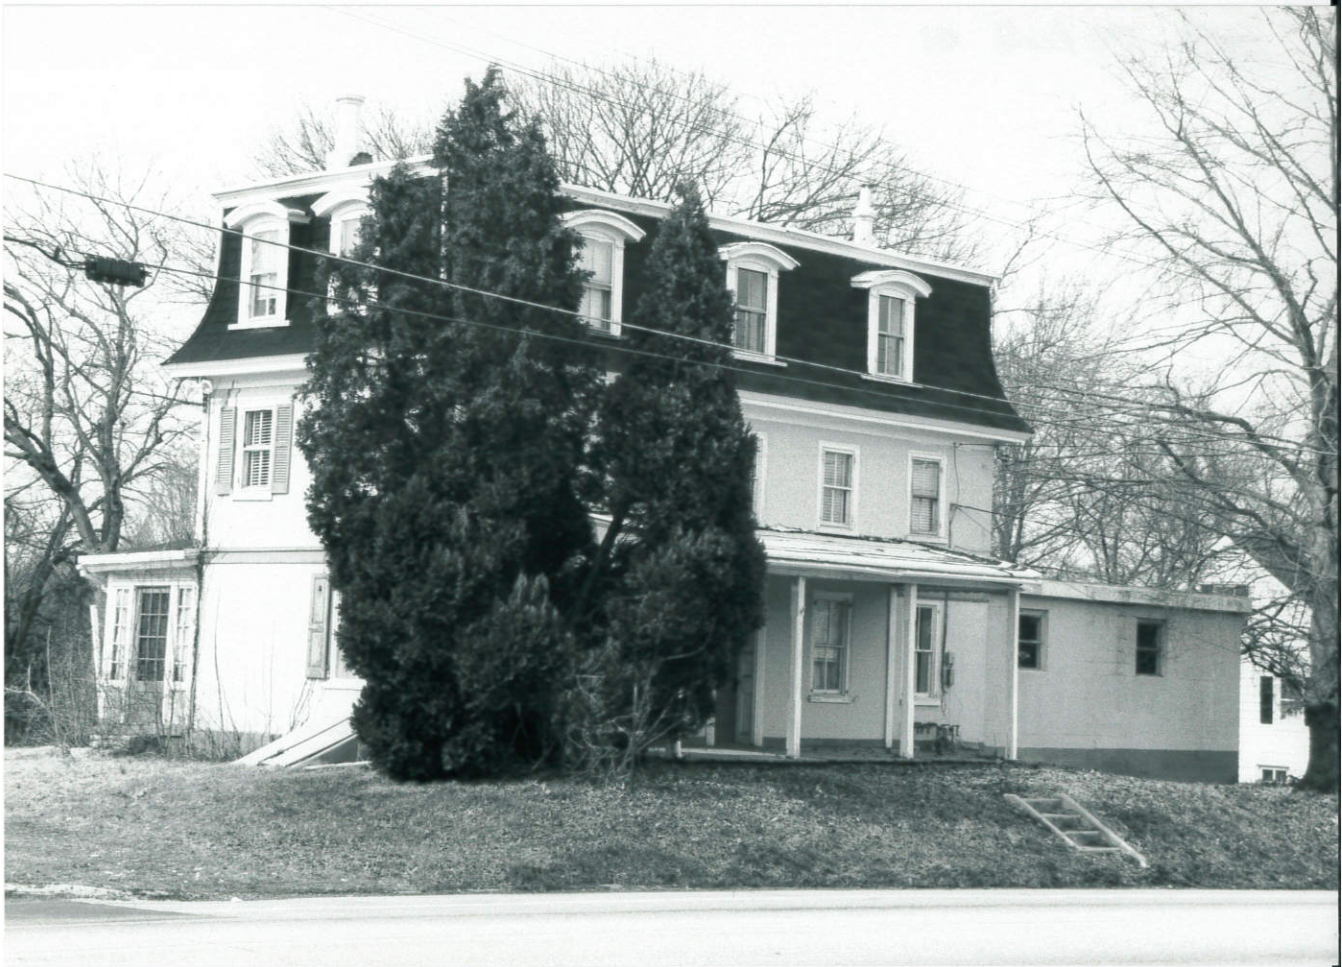
| Number | Description of View | Direction of Camera |
|---|---|---|
| 2 | House – façade (right) | |
