PENNSYLVANIA HISTORIC RESOURCE SURVEY FORM PHOTO/SITE PLAN SHEET

Address: 1750 Skippack Pike

Surveyor Name/Title: Robert Wise Date: 6/16/2000
Project Name: Whitpain Township Historic Resource Survey
Organization: Robert Wise Consulting/Whitpain Township Telephone: (610) 722-5818
Street and No.: Station Square 1, Suite 104, 37 North Valley Road
City, State: Paoli, Pa Zip Code: 19301
Additional Survey Documentation: n/a
Associated Survey Codes: n/a

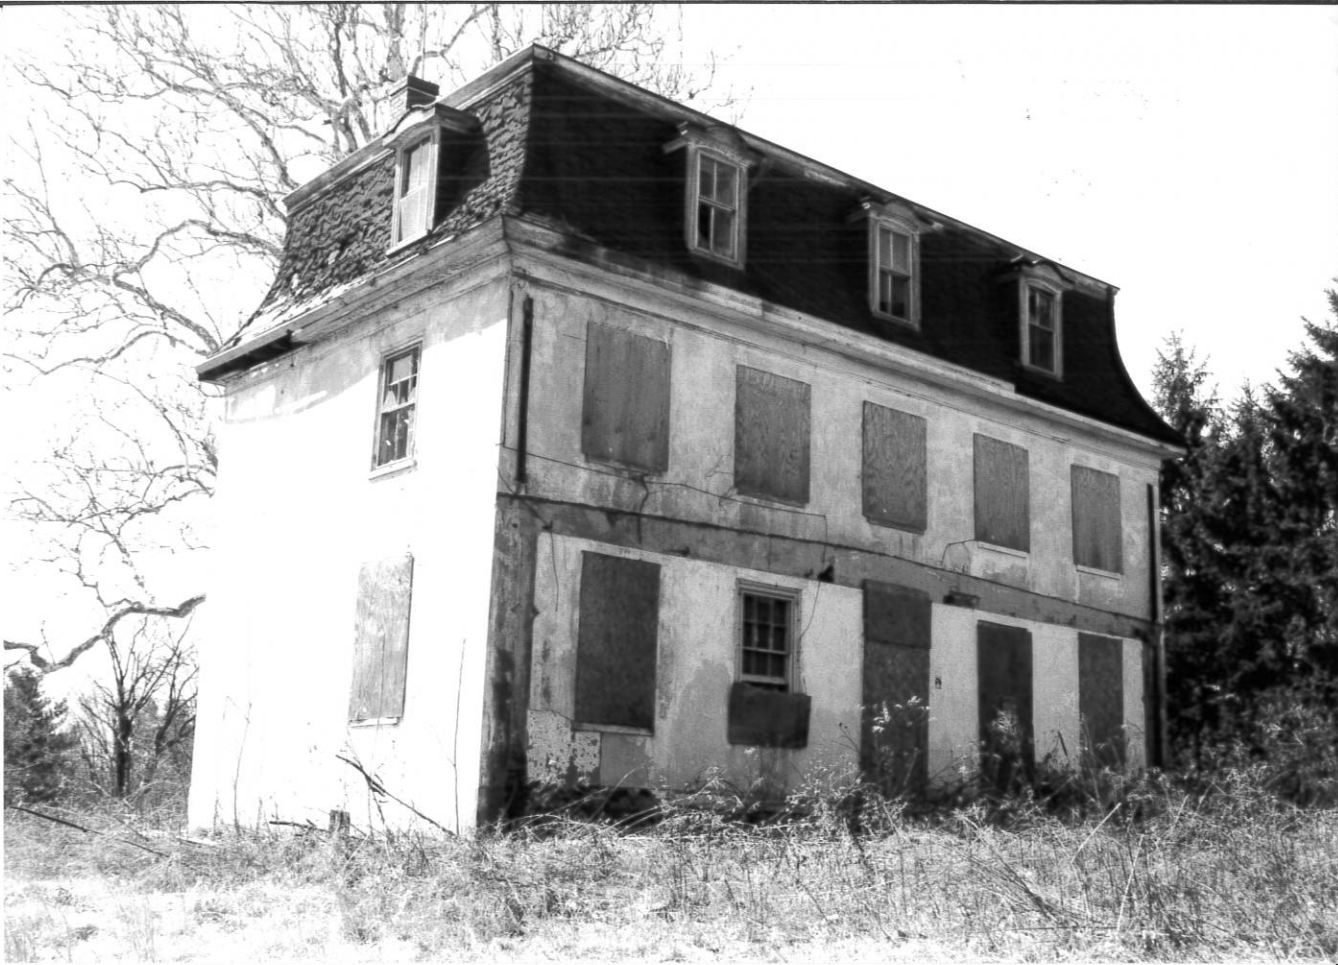
Number	Description of View	Direction of Camera
1	House – façade	
2	House – façade	
3		
4		
5		
6		
Photographer Name: Robert Wise		Date: 1999

This 3 story, Second Empire style house, c. 1870, sits abandoned and boarded-up near the entrance of a townhouse development. It consists of the core and rear addition, forming an ell-shape. The core has an asphalt shingled, flared Mansard style roof with front and side dormers. A small brick chimney is located near the rear wall. The walls are stucco over brick, with watermark. The house is 5-bays wide with center door. While the first and second floor openings are sealed, those on the dormers are 2x2 plate glass units. The dormers have curved pedimented roofs. (There are three dormers on the front façade.) Markings indicated a porch was once attached to the front of the house, but is now removed. The core measures 40' x 28'.

The addition is a 2-story, stucco-clad, flat roofed extension on the rear of the core. Together, the house, which is ell-shaped, measures 40' x 48'.

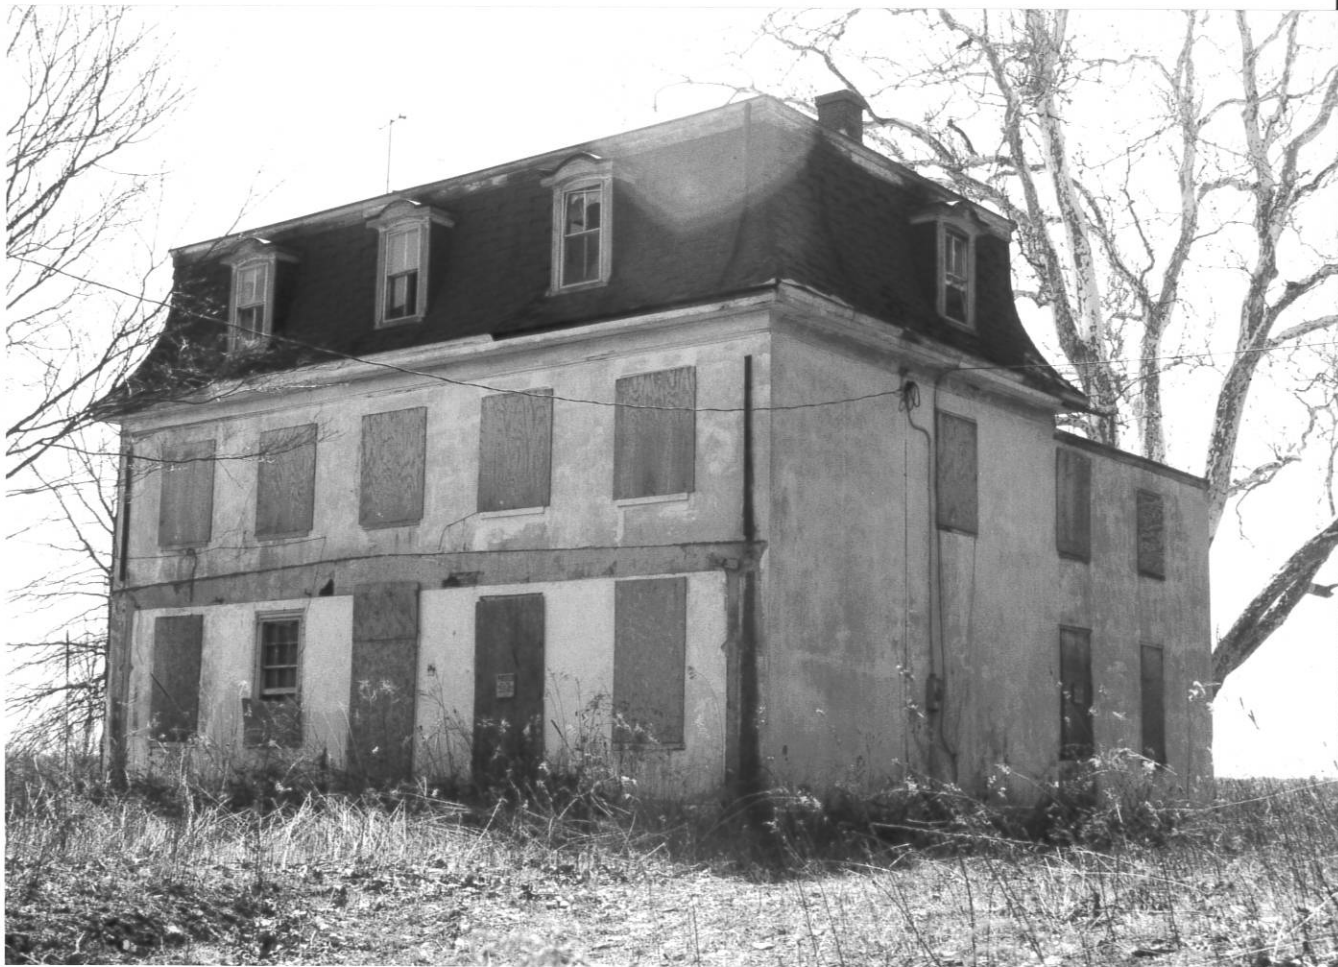
Classification: Class II. The house is in poor condition and, due to the development, has lost much of its context.
