PENNSYLVANIA HISTORIC RESOURCE SURVEY FORM PHOTO/SITE PLAN SHEET

Municipality: Whitpain Township Address: 1950 Skippack Pike

Surveyor Name/Title: Robert Wise Date: 6/16/2000
Project Name: Whitpain Township Historic Resource Survey
Organization: Robert Wise Consulting/Whitpain Township Telephone: (610) 722-5818
Street and No.: Station Square 1, Suite 104, 37 North Valley Road
City, State: Paoli, Pa Zip Code: 19301
Additional Survey Documentation: n/a
Associated Survey Codes: n/a

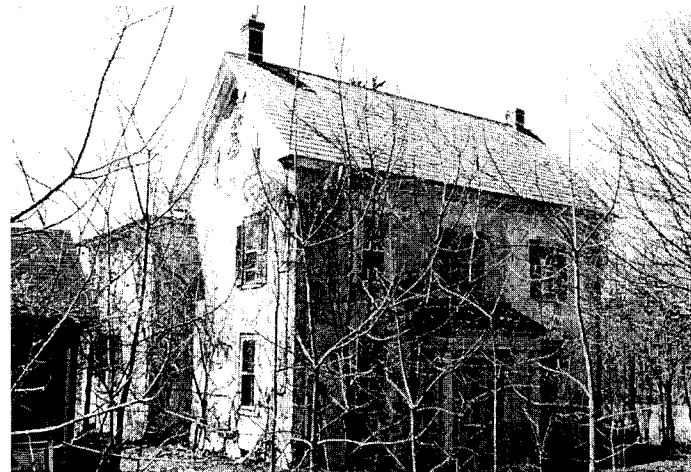
Number	Description of View	Direction of Camera
1	House – façade	
2		
3		
4		
5		
6		
Photographer Name: Robert Wise		Date: 1999

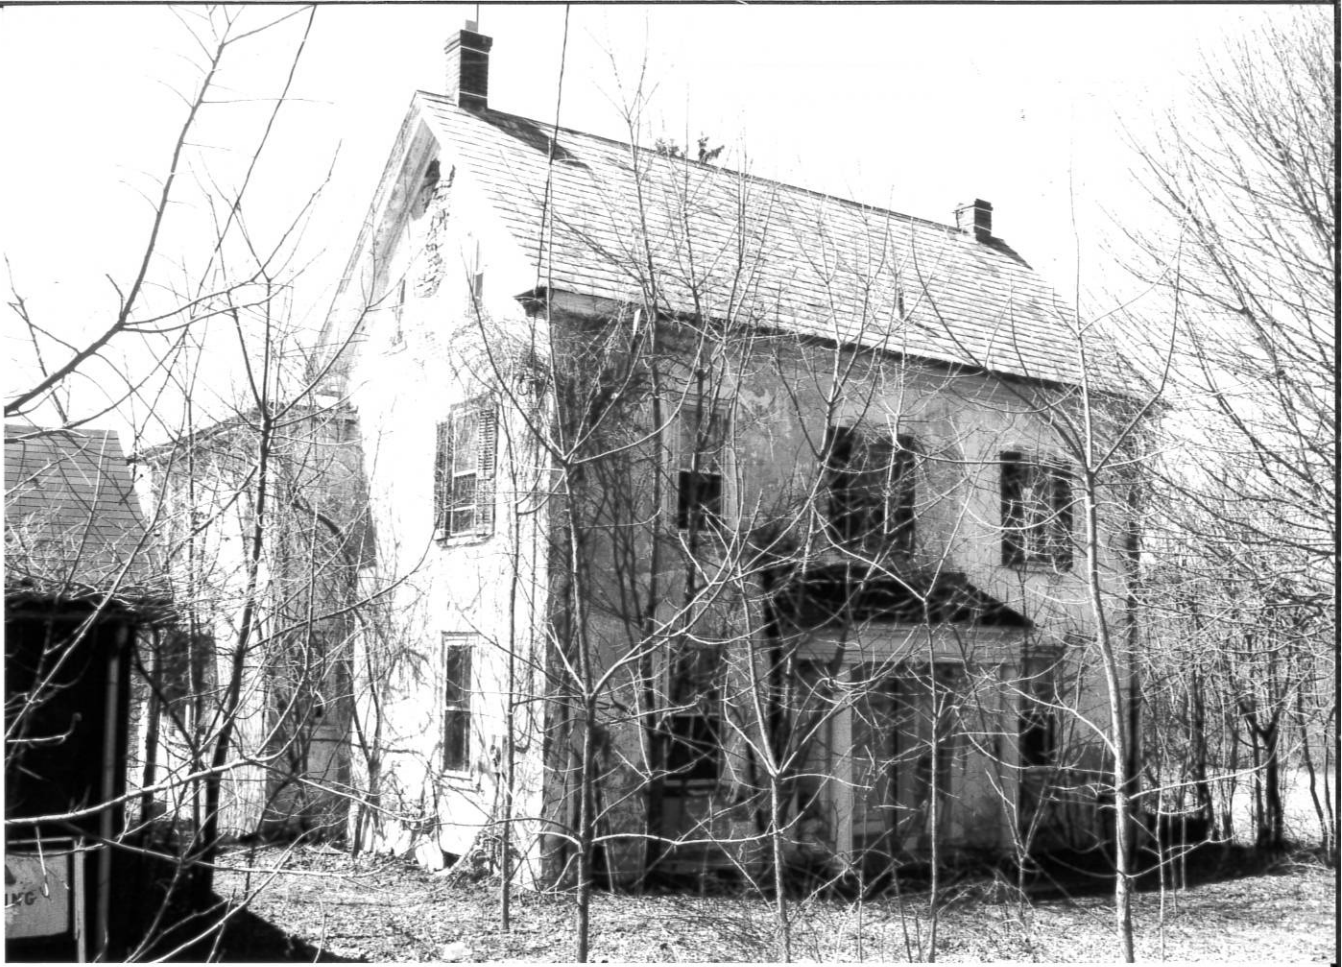
This 3-bay, 2-story vernacular farmhouse, with Federal style influences, sits abandoned and deteriorating. It consists of the core with a rear addition. Also located on the property is a single story, frame building.

The core is a symmetrical, two-story, end-gabled, three-bay building with a center entrance. The steeply pitched roof is slate. There are small, brick, flush chimneys on both ends of the house. Thick cove molding can be found under the eaves. The walls are stucco over stone. Windows are 2x2 sash. Like many houses in the Township, the attic floor features a twin window arrangement with angled tops under the gables. A portico held up by Tuscan columns protects the front entrance. The core measures 30' x 18'.

A large addition is attached to the rear of the core. It protrudes from the southern end of the core approximately 4 feet. The addition has a flat roof, cornice, and two stories. Like the core, its walls are stucco over stone. Overall, the building measures 34' x 40'.

Classification: Class II due to poor condition and alterations.
