PENNSYLVANIA HISTORIC RESOURCE SURVEY FORM PHOTO/SITE PLAN SHEET

Municipality: Whitpain Township Address: 1953 W. Township Line Road

Surveyor Name/Title: Robert Wise Date: 6/16/2000
Project Name: Whitpain Township Historic Resource Survey
Organization: Robert Wise Consulting/Whitpain Township Telephone: (610) 722-5818
Street and No.: Station Square 1, Suite 104, 37 North Valley Road
City, State: Paoli, Pa Zip Code: 19301
Additional Survey Documentation: n/a
Associated Survey Codes: n/a

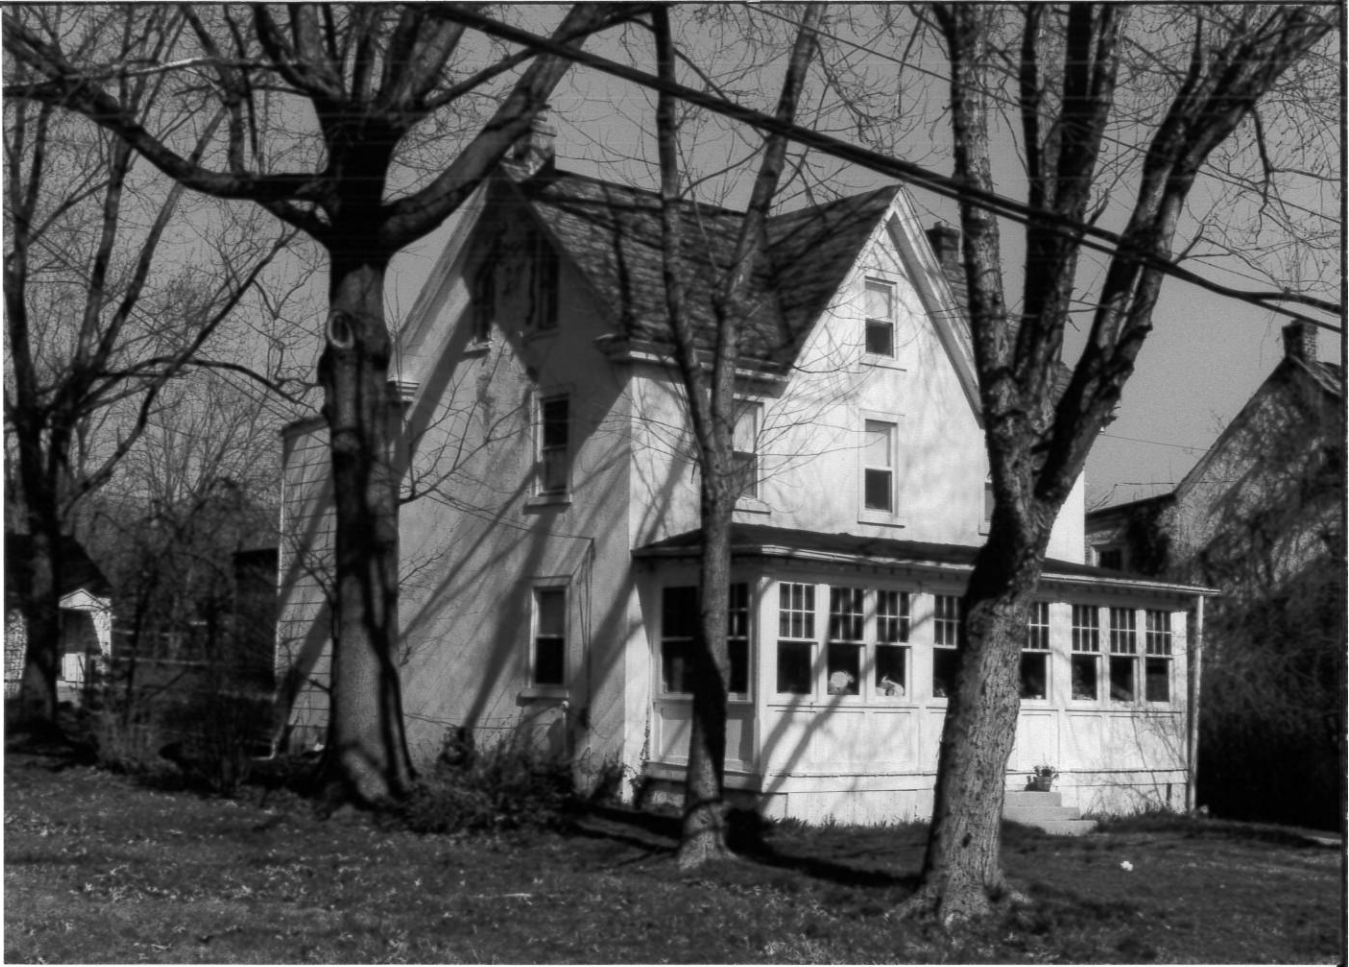
Number	Description of View	Direction of Camera
1	House – façade (left)	
2	House – façade (right)	
3		
4		
5		
6		
Photographer Name: Robert Wise		Date: 1999

This Victorian Gothic house was originally the twin of 1999 West Township Line Road. Built c. 1860, the house is a 30 x 30, two and a half story end gabled, three bay structure clad in stucco. There is also a centered gable on the façade with a window inside. There are two interior end chimneys. There are twin pointed windows on the side gables as well. The remaining windows do not have shutters. A large one story enclosed porch adorns the façade and has a band of windows. A rear two-story frame shed runs the length of the house.
