PENNSYLVANIA HISTORIC RESOURCE SURVEY FORM PHOTO/SITE PLAN SHEET

Municipality: Whitpain Township Address: 1961 Skippack Pike

Surveyor Name/Title: Robert Wise Date: 6/16/2000
Project Name: Whitpain Township Historic Resource Survey
Organization: Robert Wise Consulting/Whitpain Township Telephone: (610) 722-5818
Street and No.: Station Square 1, Suite 104, 37 North Valley Road
City, State: Paoli, Pa Zip Code: 19301
Additional Survey Documentation: n/a
Associated Survey Codes: n/a

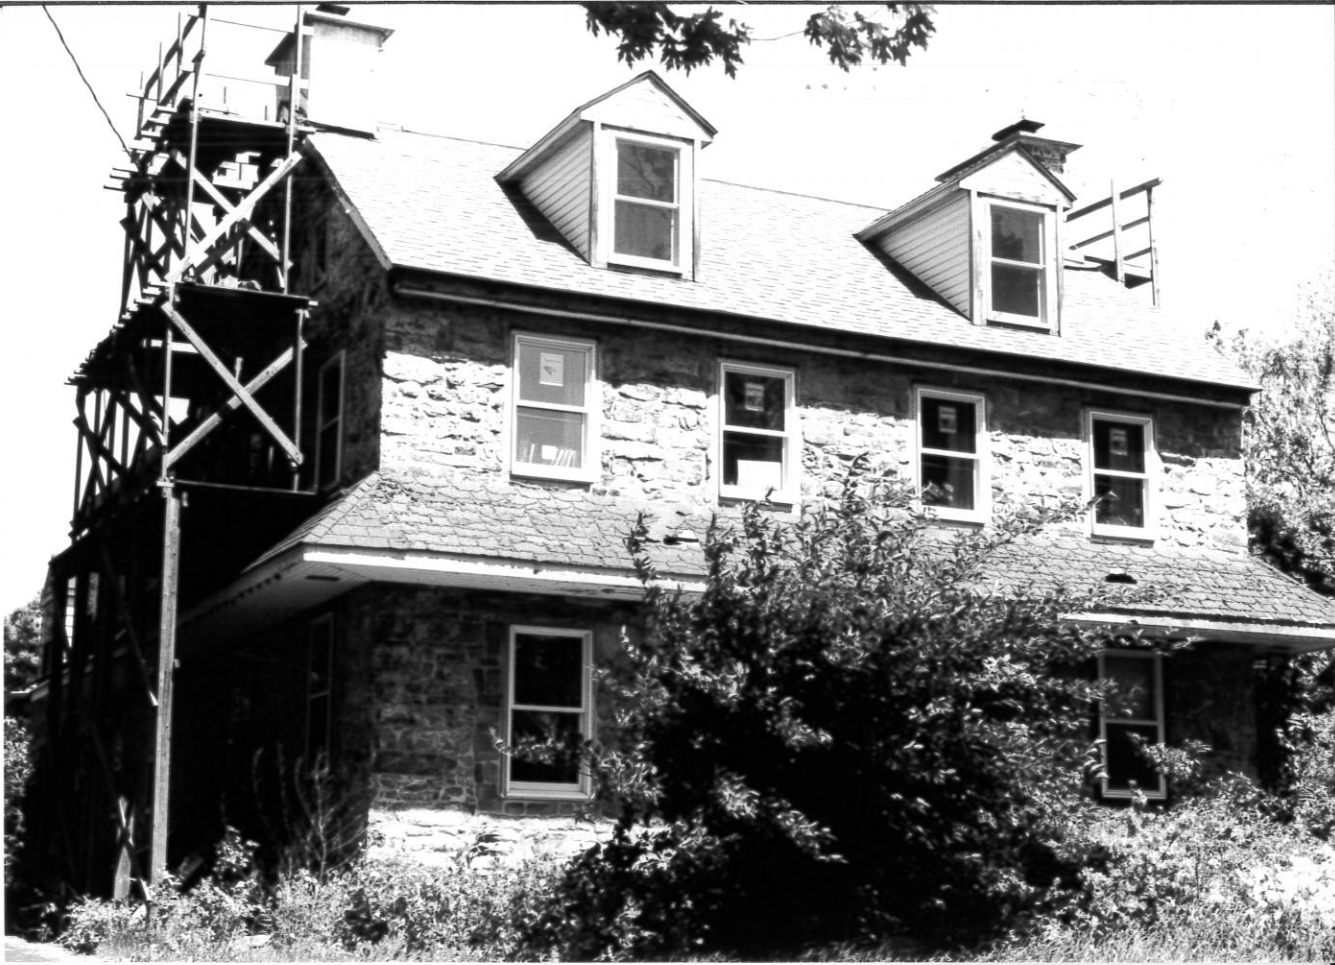
Number	Description of View	Direction of Camera
1	House – façade	
2	House – façade	
3		
4		
5		
6		
Photographer Name: Robert Wise		Date: 1999

This Georgian Colonial house is located several hundred feet off Skippack Pike. It consists of a 2.5-story, fieldstone core, an older addition creating an el-shape, a two story stone addition constructed within the void of the el (north side), and a 1.5 story addition on the rear. Major characteristics of the core include its two clapboard sided, gabled pedimented dormers, its end-gabled asphalt shingled roof, and a wrap-around pent roof. The house consists of four bays with new 1x1 sash windows; the doors are also new. (The building seems to be undergoing a lengthy restoration process as older scaffolding is located on both ends of the house.

The addition on the north side is a 2-story, stone extension. The 1.5 rear addition has stucco walls and dormers.
