PENNSYLVANIA HISTORIC RESOURCE SURVEY FORM - DATA SHEET

Survey Code: 139 Tax Parcel/Other No.: 66 00 06688 00 5 Block Unit #009-021
County: 1. Montgomery 091 2. _____
Municipality: 1. Whitpain Township 2. _____
Address: 1487 Skippack Pike Historic Name: _____
Other Name: _____
Owner Name/Address: Patrick A. Kane 1487 Skippack Pike Center Square PA 19422
Owner Category: Private Public-local Public-state Public-federal
Resource Category: Building District Site Structure Object
Number/Approximate Number of Resources Covered by This Form: 2
USGS Quad: 1. Lansdale 2. _____
UTM A. _____ C. _____
References: B. _____ D. _____

Surveyor Name/Title: Robert Wise Date: 6/16/2000
Project Name: Whitpain Township Historic Resource Survey
Organization: Robert Wise Consulting/Whitpain Township Telephone: (610) 722-5818
Street and No.: Station Square 1, Suite 104, 37 North Valley Road
City, State: Paoli, Pa Zip Code: 19301
Additional Survey Documentation: n/a
Associated Survey Codes: n/a

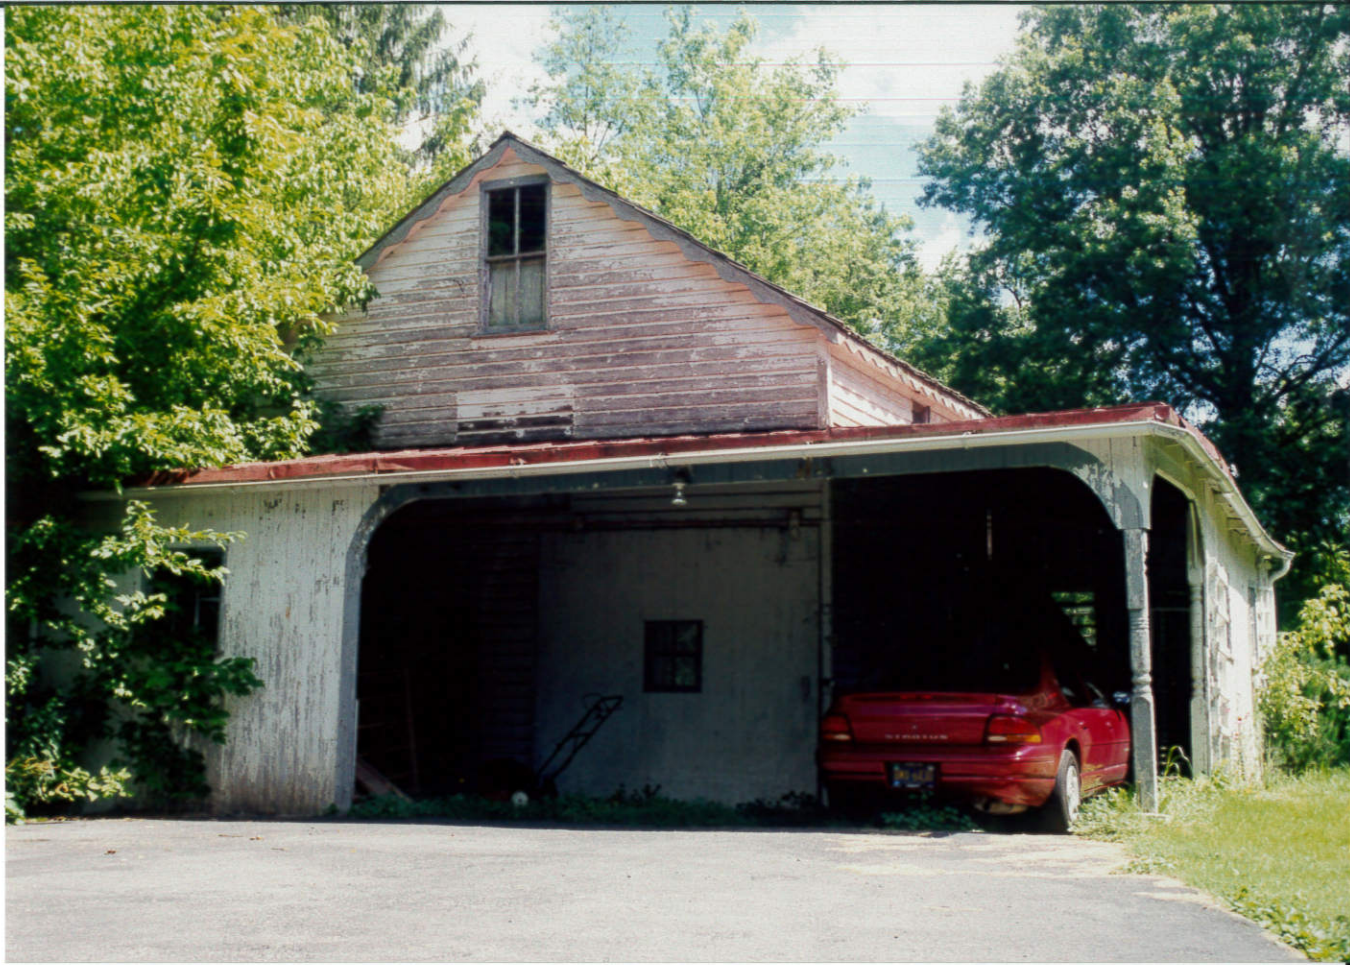
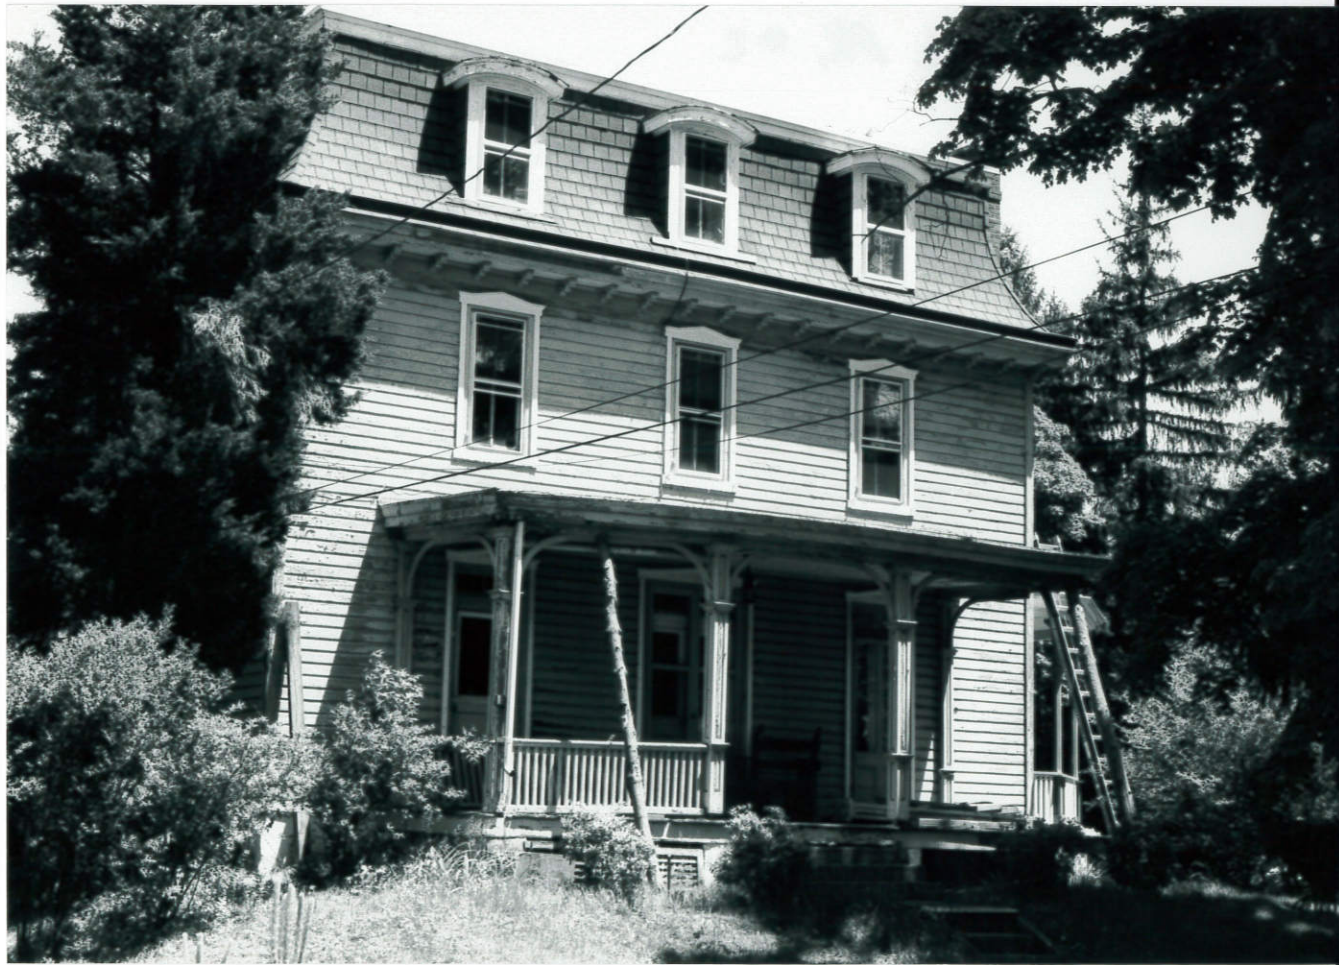
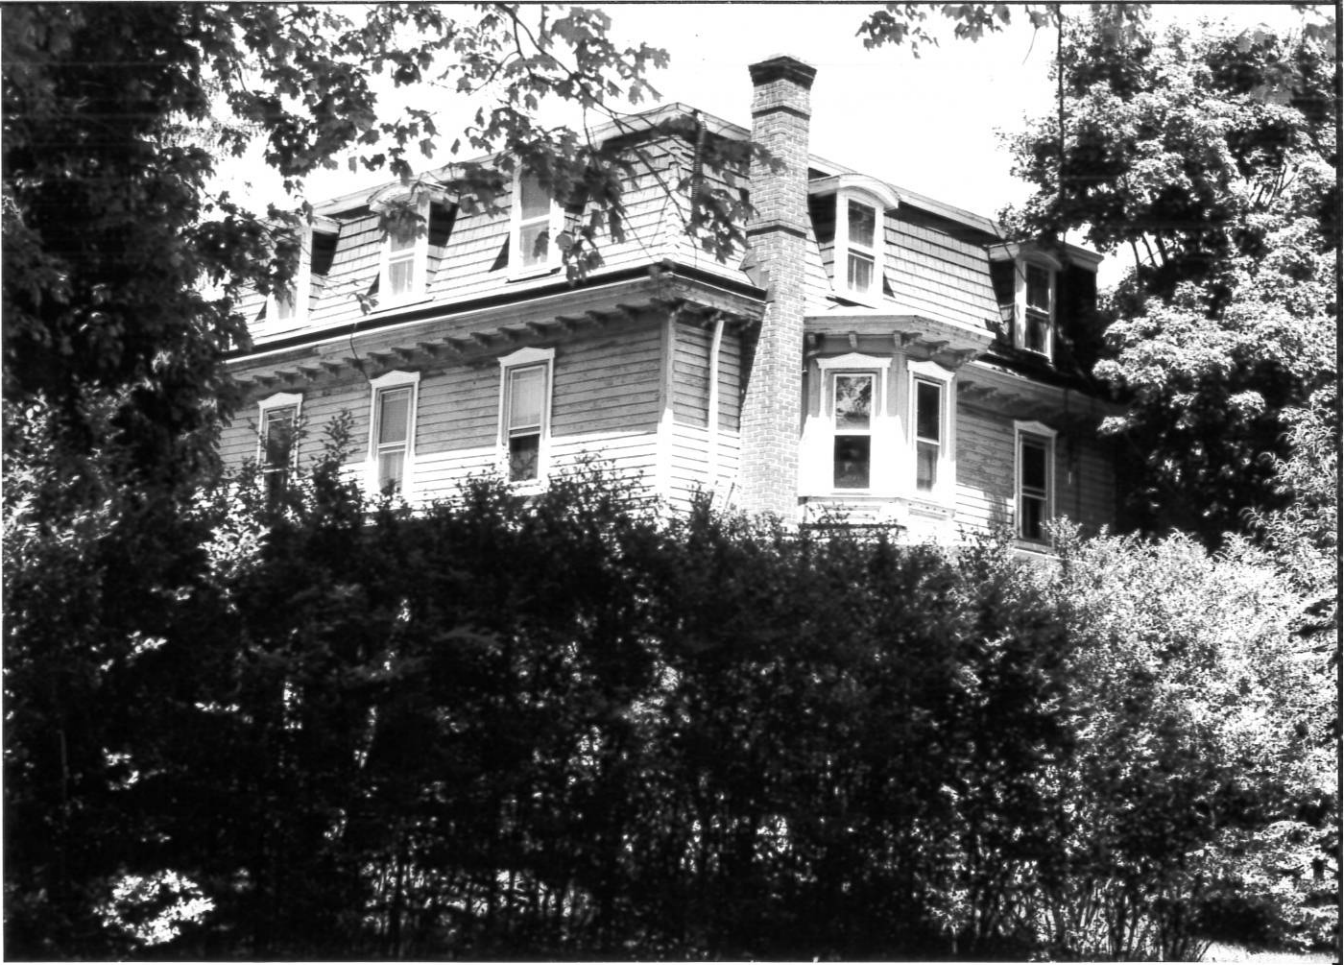
This Second Empire-style, Mansard Roofed house (c. 1870) consists of a three-story core clad in German siding. The house is a fine example of the Township's Second Empire influence and consists of several details popularized by the style. Some of these details include its concave Mansard roof, curved molded dormers, exaggerated cornice above and below roof, bracketed cornice, and large 2x2 sash windows. The house measures 30' across (three bay) and 30' deep. Barrel topped, molded dormers are located across the front and side facades. A flat-roofed front porch, supported by decorative brackets and posts, is located on the main facade. Entrance to the house is through two French doors and a single door, all located under the front porch. A transom is located over each door way. Windows and doors are topped with pedimented lintels. Unlike similar houses in the Township, the house has two, two-story bay window extensions on the east and west sides. The roof consists of asphalt shingles. A single brick chimney is located on the east side, interrupting the cornice.

Associated Resource: (Barn). There is a contributing barn to the rear of the house. It is a frame building with a gabled roof. A vergeboard with a wave pattern frames the roof. At some time in its history, some of the windows were closed in and a one-story wrap-around porch was constructed. This porch rests upon columns which resemble large spindles.

Classification: The house is in fair shape but is in need of repainting and associated wood repairs. Although it is clad in German siding and not stucco, it is characteristic of the Mansard tradition in the Township. It is a Class II resource.
